# **Debris/Ice/TPS Assessment and Integrated Photographic Analysis of Shuttle Mission STS-73**

*Gregory N. Katnik, Barry C. Bowen, Jill D. Lin,  
Vehicle Engineering/Mechanical System Division/ET-SRB Branch,  
Kennedy Space Center, Florida*

**20 October 1995**

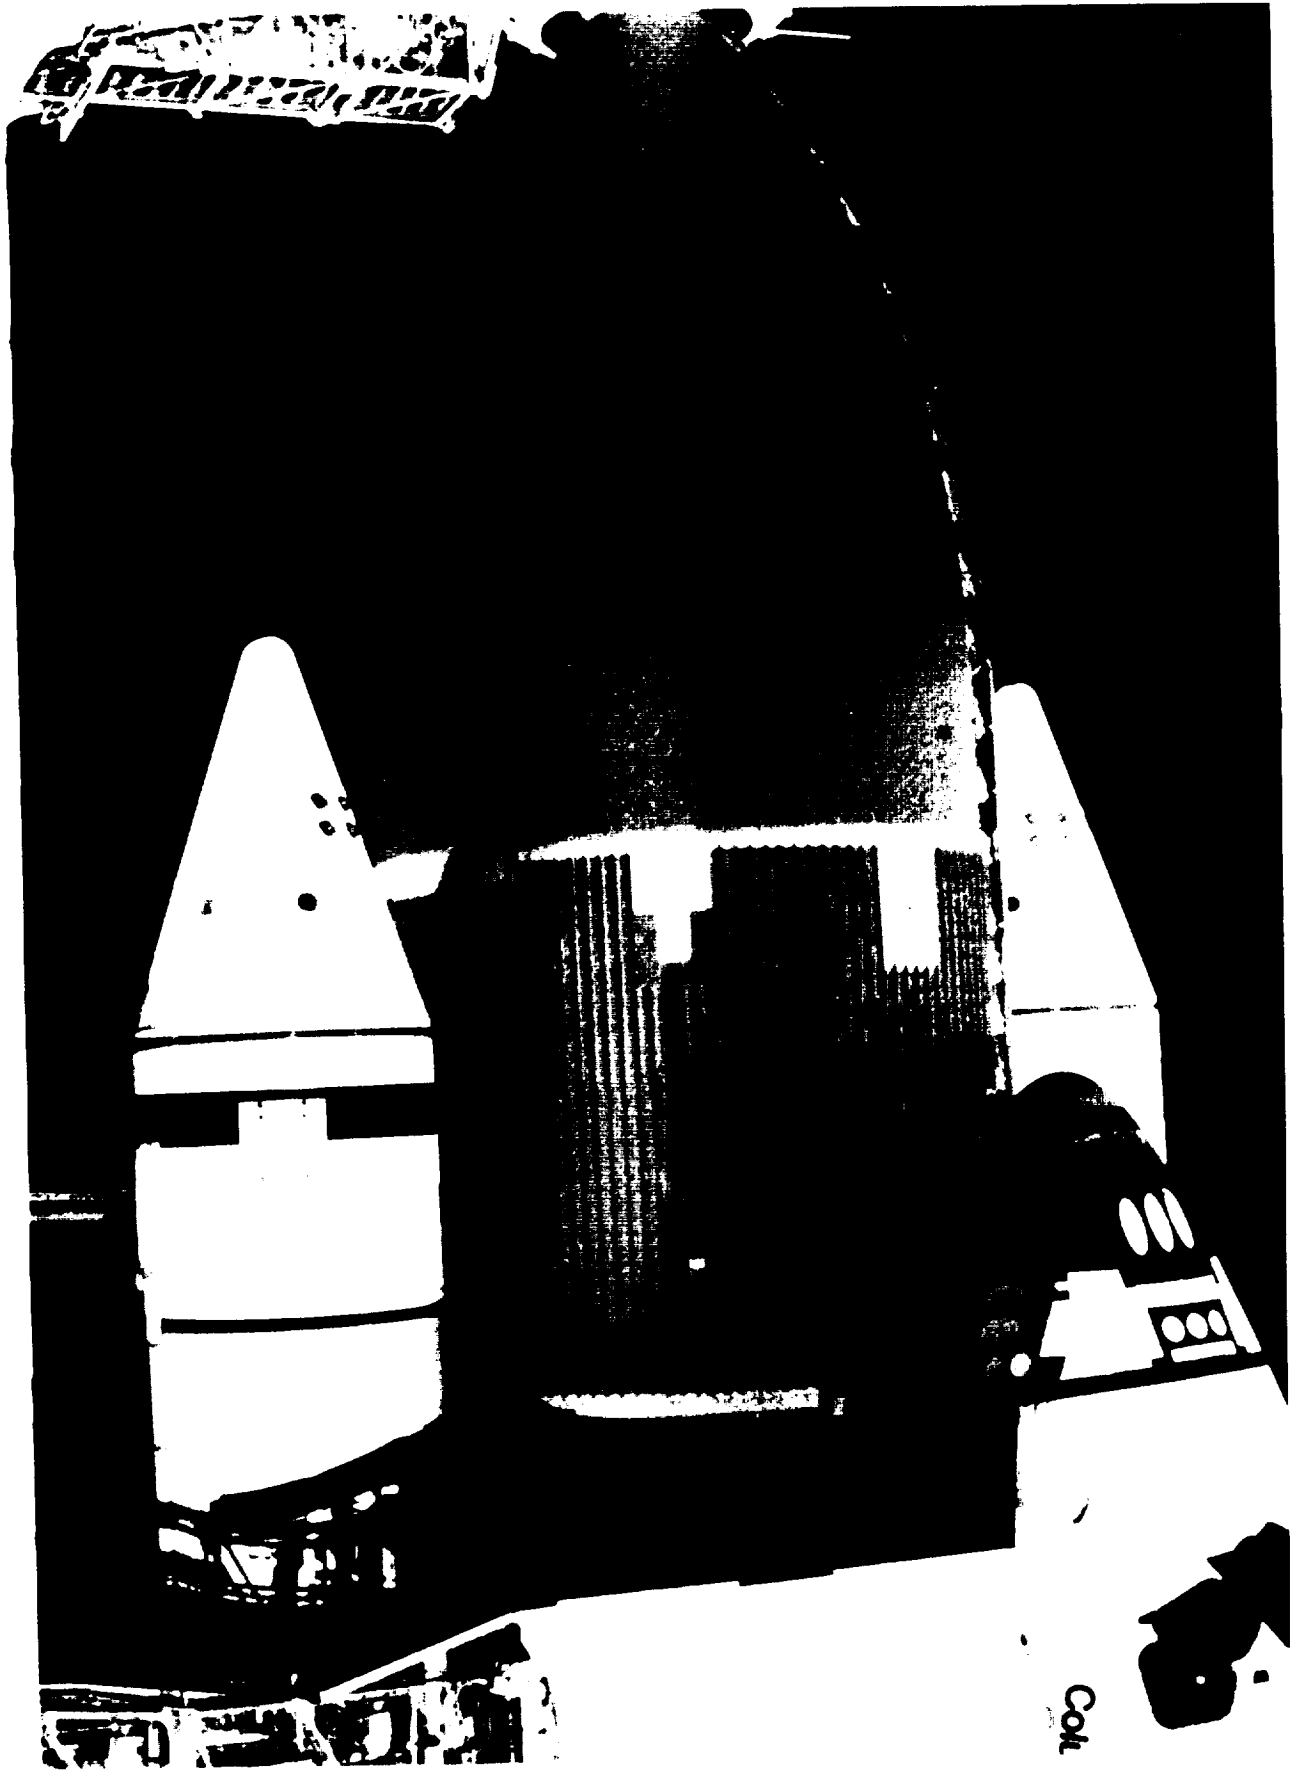
**Photo 7 : ET-73 Cryoloaded for Launch**

There was no acreage ice or frost given the ambient weather conditions at this time of year.  
There were no protuberance icing conditions outside of the established data base

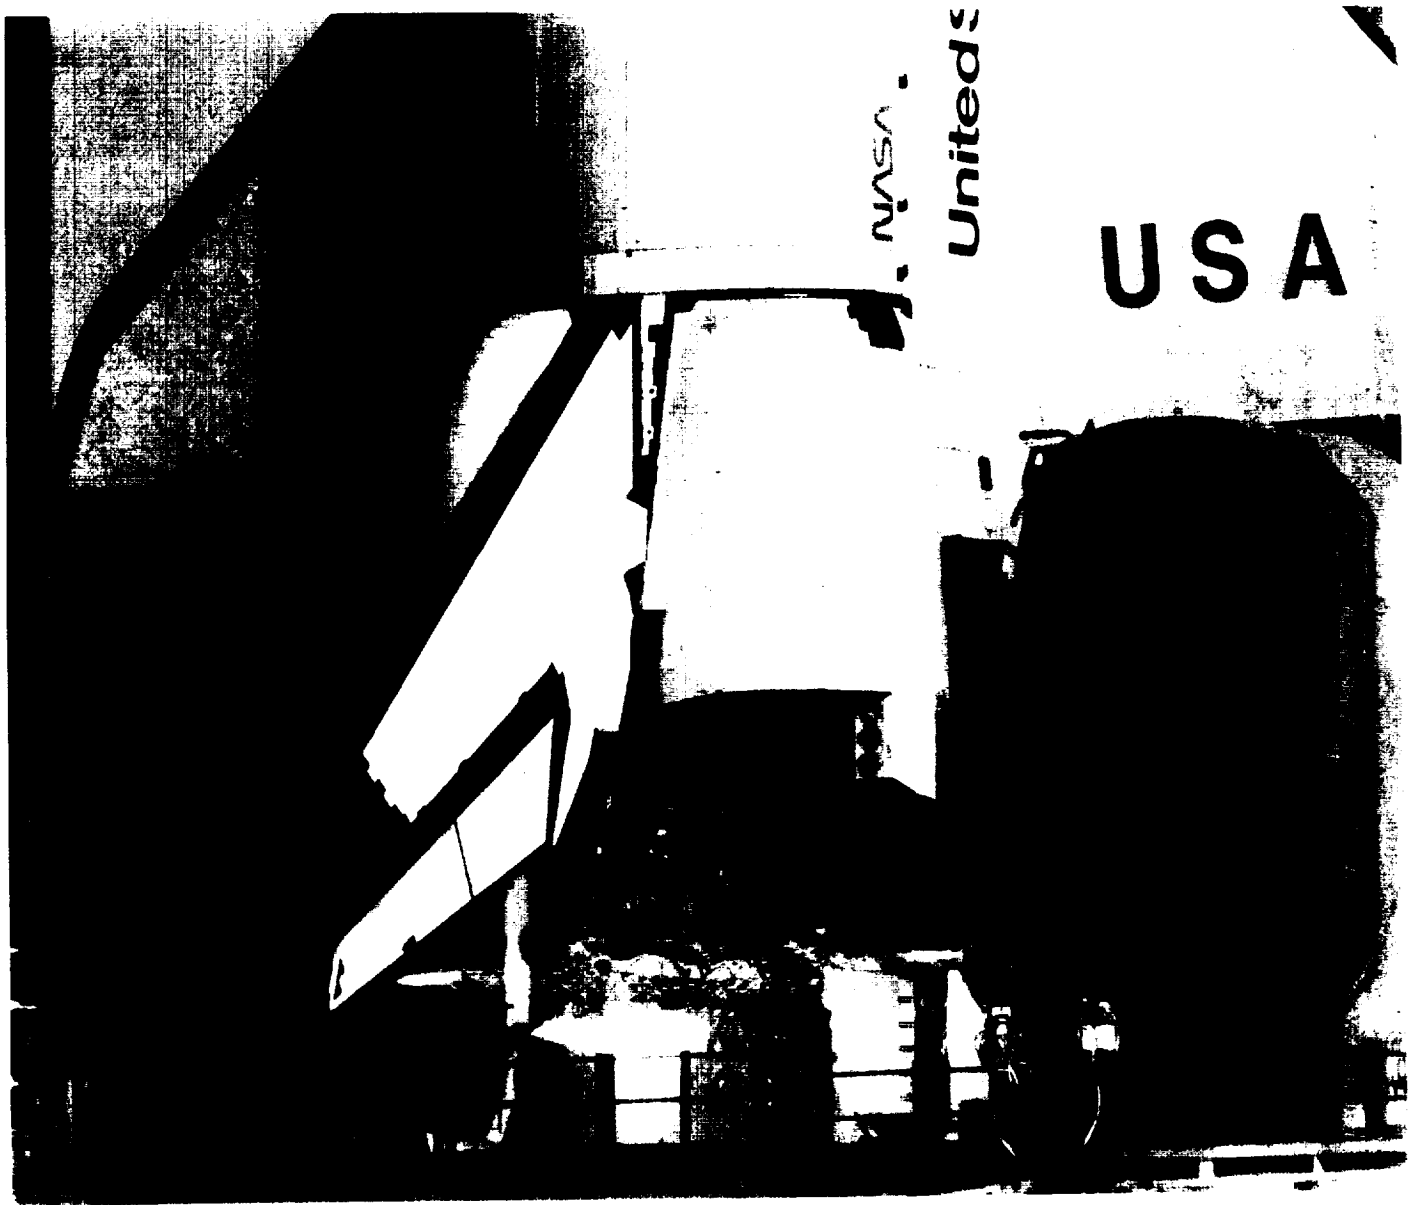
**Photo 10: SSME Mach Diamond Formation**

SSME ignition appeared normal with the exception of Mach diamonds forming in a 2-3-1 sequence. This was caused by the Phase II/Block I mix of SSME's with slightly different startup times.

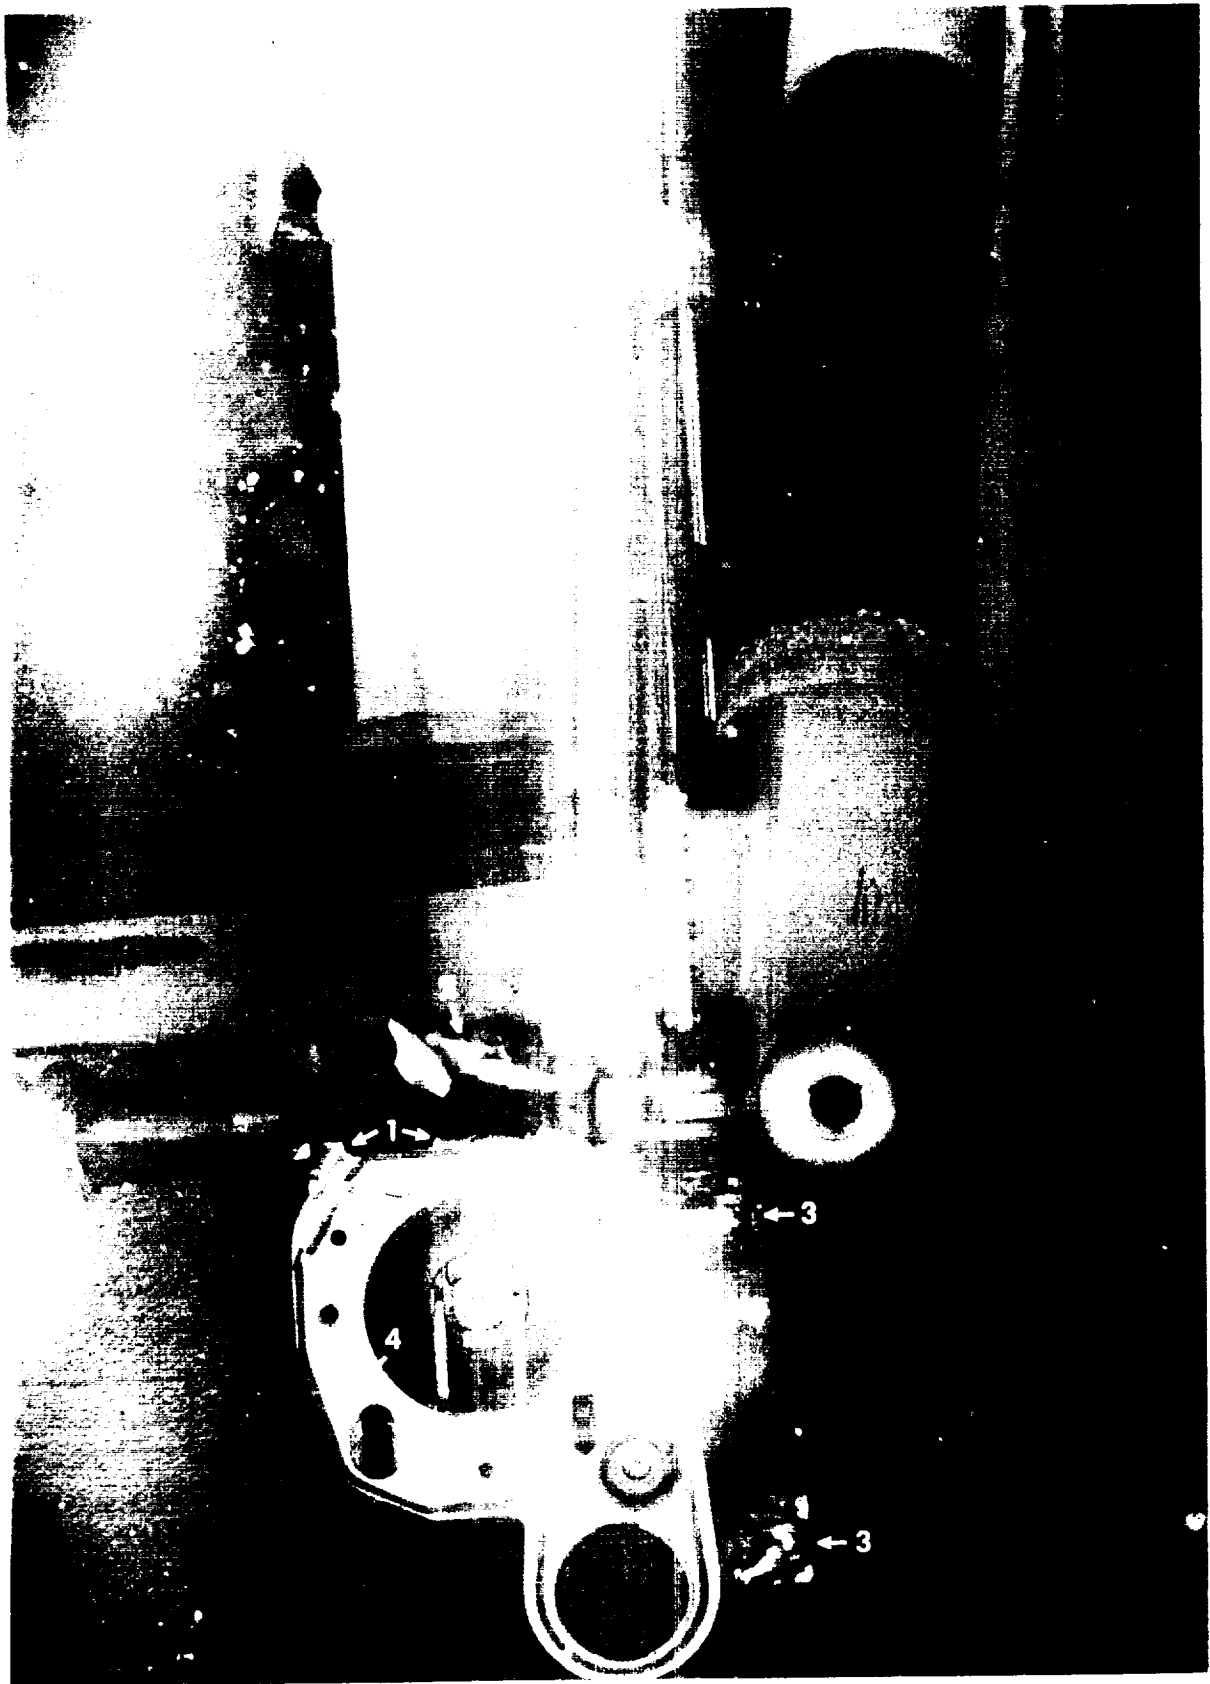
**Photo 16: ET/ORB LO2 Umbilical**

The LO2 ET/ORB umbilical sustained TPS damage at the top and inboard forward corner. Pieces of loose foam from these damaged areas were wedged against the aft side of the crossbeam. Numerous divots and eroded areas were visible on the horizontal and vertical sections of the cable tray. Lightning contact strips across the forward part of the umbilical and at the 8 o'clock position were missing. Loss of lightning contact strips was the subject of a previous IFA. A thin, metallic-foil object, believed to be the small lightning contact strip from the 8 o'clock position, drifted across the camera field of view after ET sep (frame 8289).

The LO2 ET/ORB umbilical sustained TPS damage at the top and inboard forward corner (1). Pieces of loose foam from these damaged areas were wedged against the aft side of the crossbeam (2). Numerous divots and eroded areas were visible on the horizontal and vertical sections of the cable tray (3). Lightning contact strips across the forward part of the umbilical and at the 8 o'clock position were missing (4).

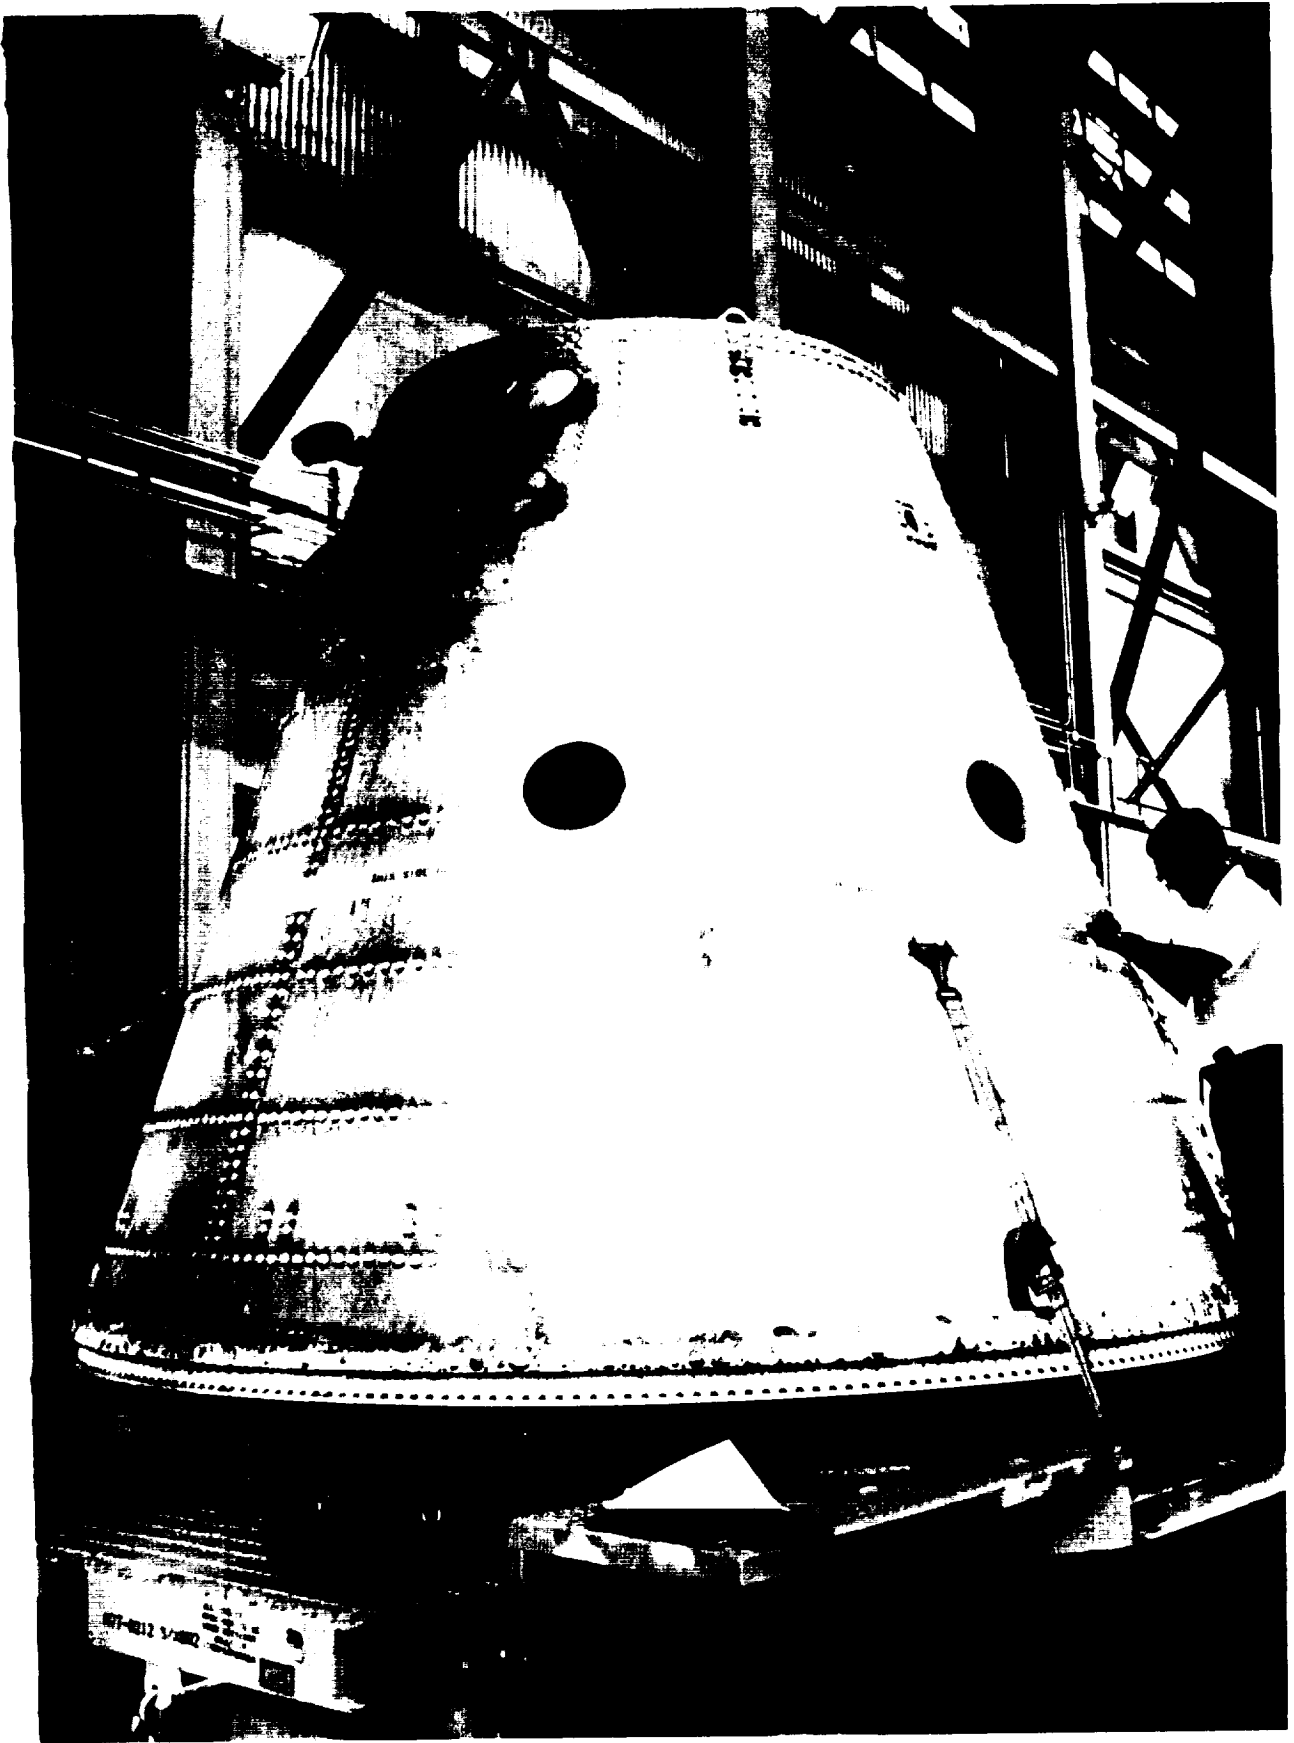
**Photo 19: RH Frustum**

The RH frustum was missing no TPS. The number of debonds (67) over fasteners was greater than average. The BSM aero heat shield covers had locked in the fully opened position though the upper left cover attach ring had been bent by parachute riser entanglement.

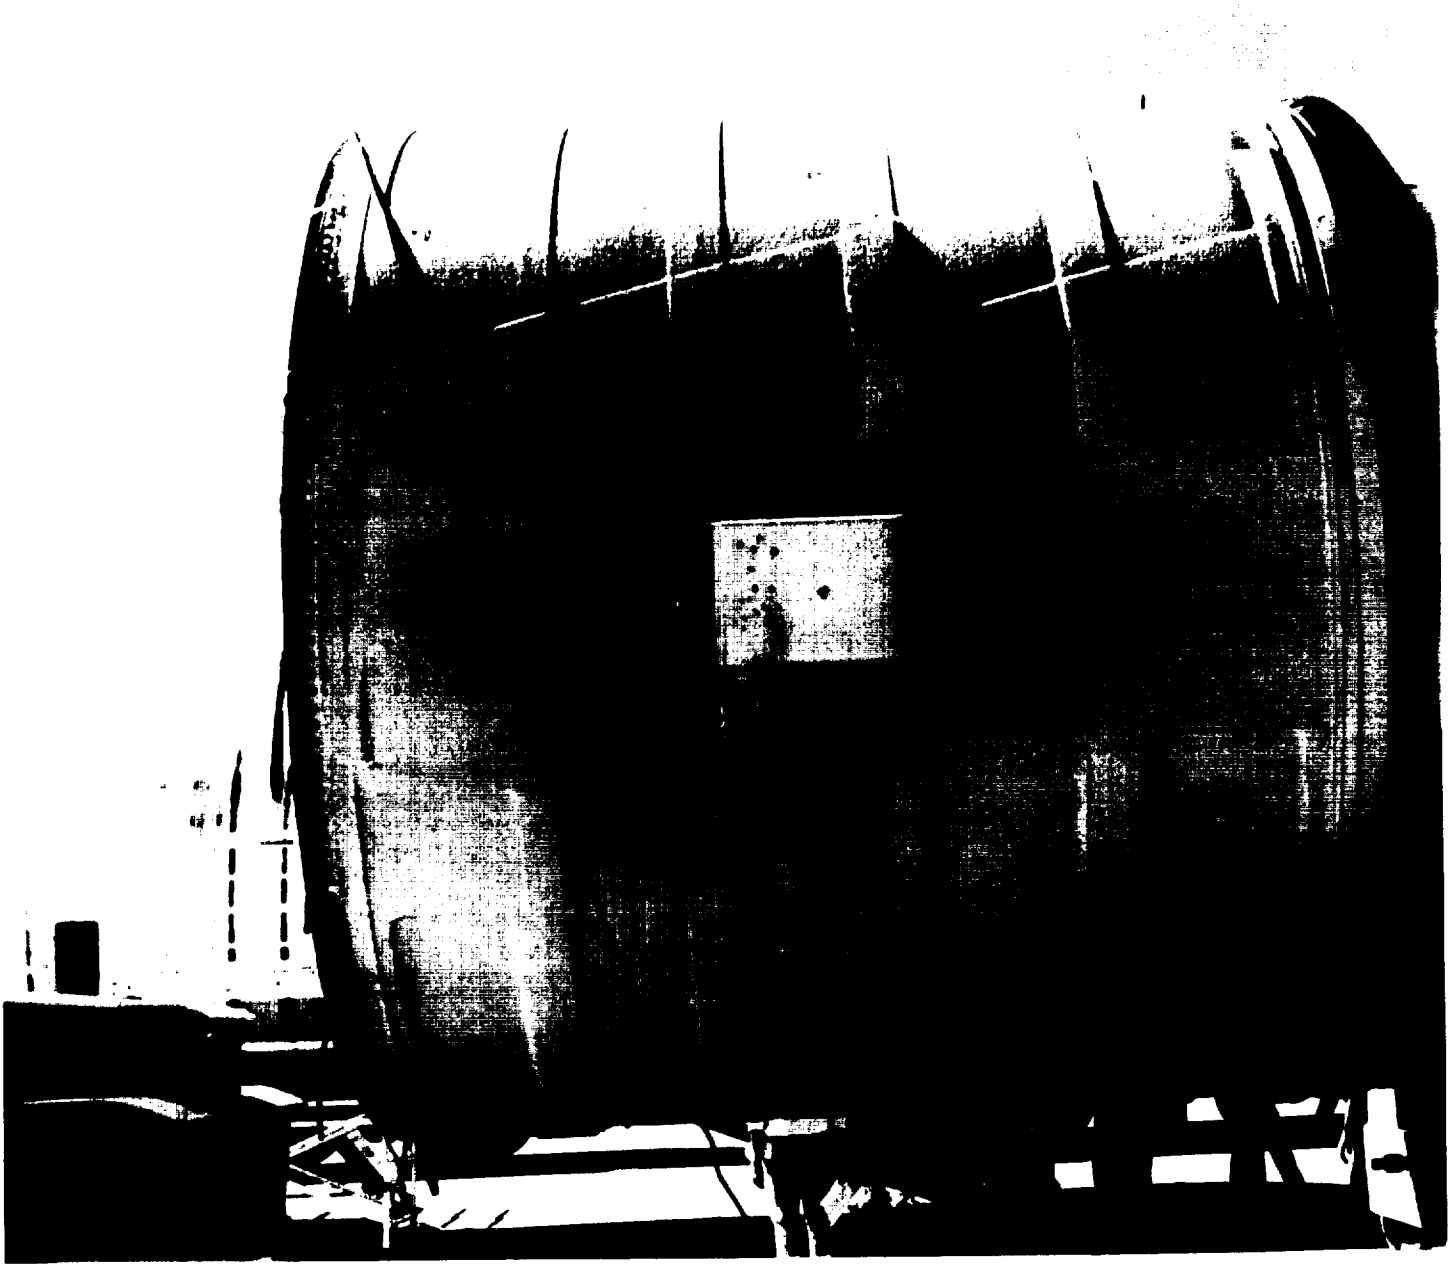
**Photo 20: RH Forward Skirt**

The RH forward skirt exhibited no debonds or missing TPS. Both RSS antennae covers/phenolic base plates were intact. Hypalon paint was blistered/missing over the areas where BTA closeouts had been applied.

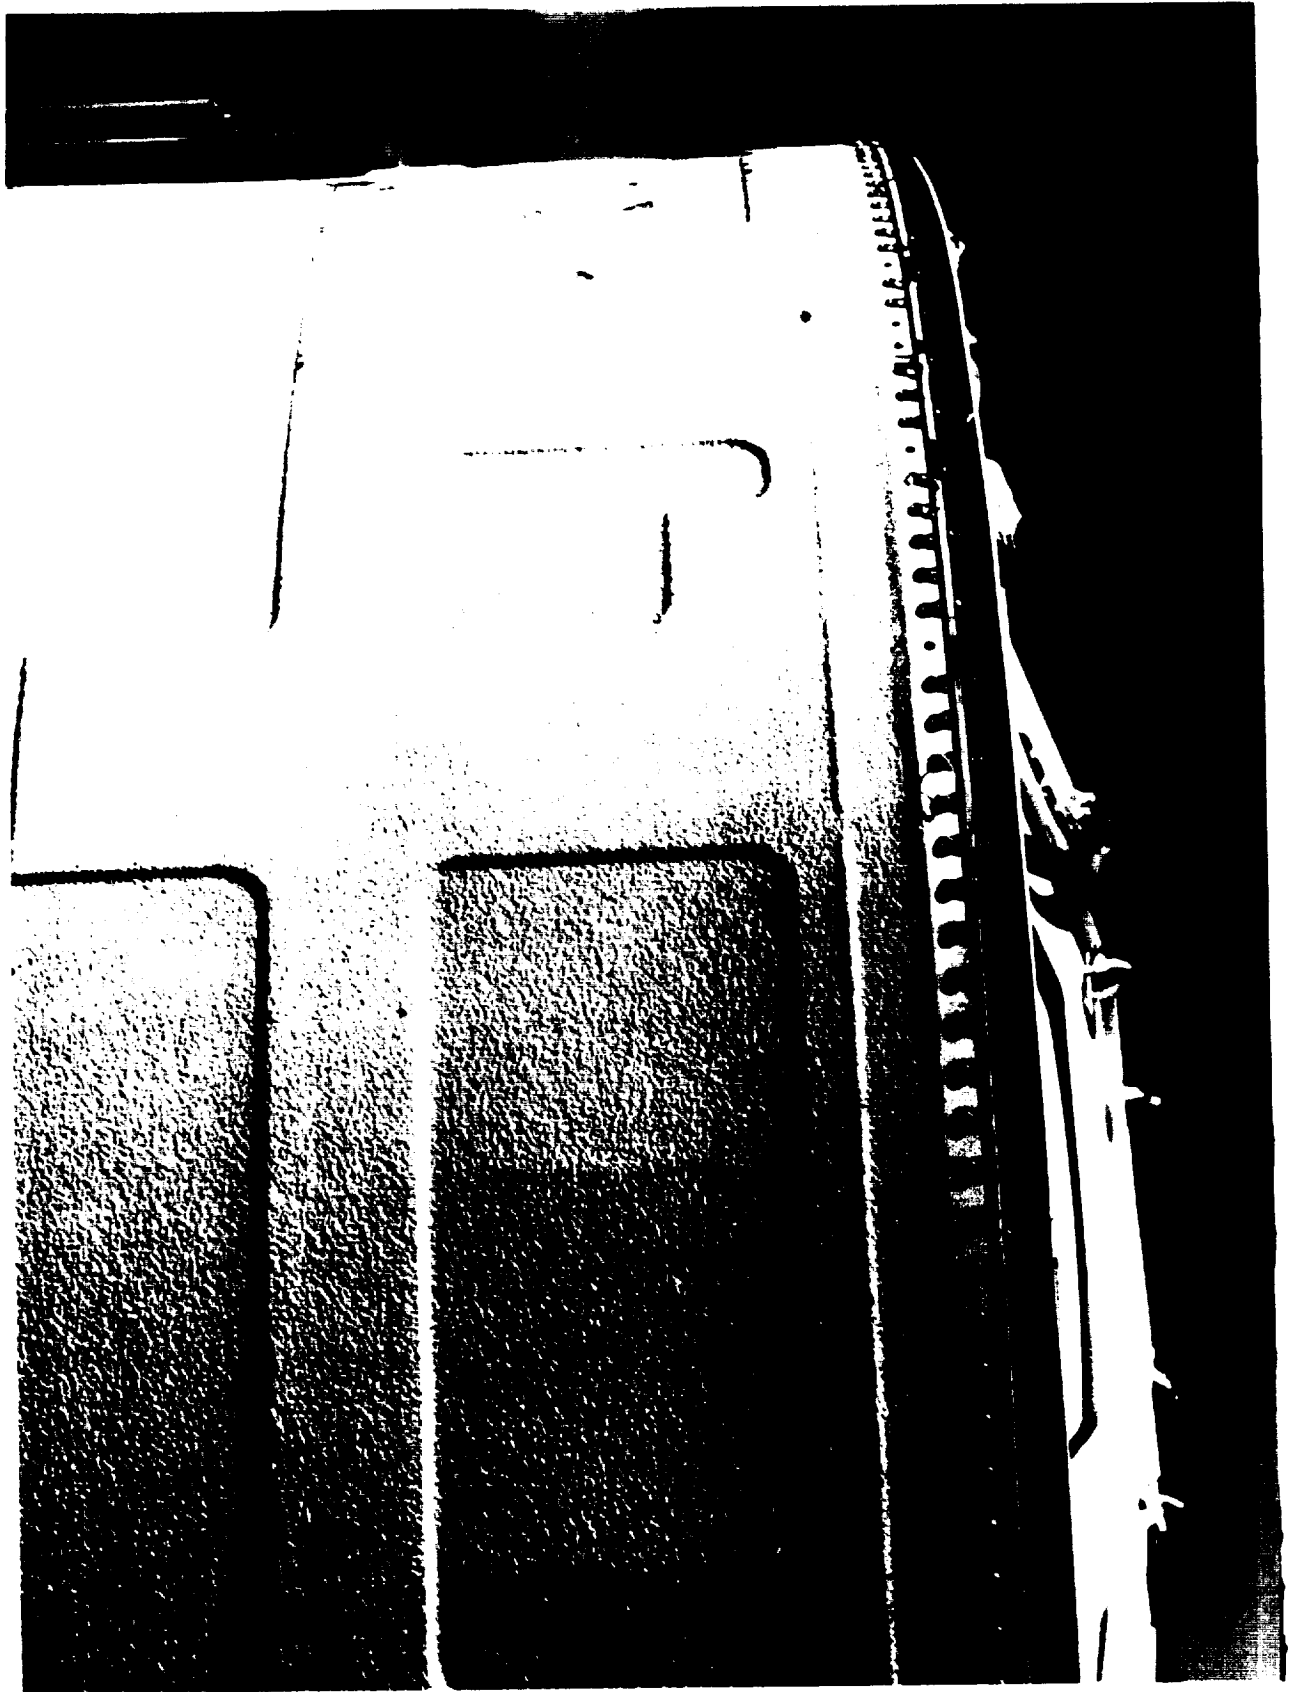
**Photo 21: Severance Ring Pins and Retainer Clips**

Numerous pins and retainer clips were missing from the frustum severance ring. Strands of nylon fiber caught on adjacent clips indicated the damage was caused by the parachute risers after splashdown.

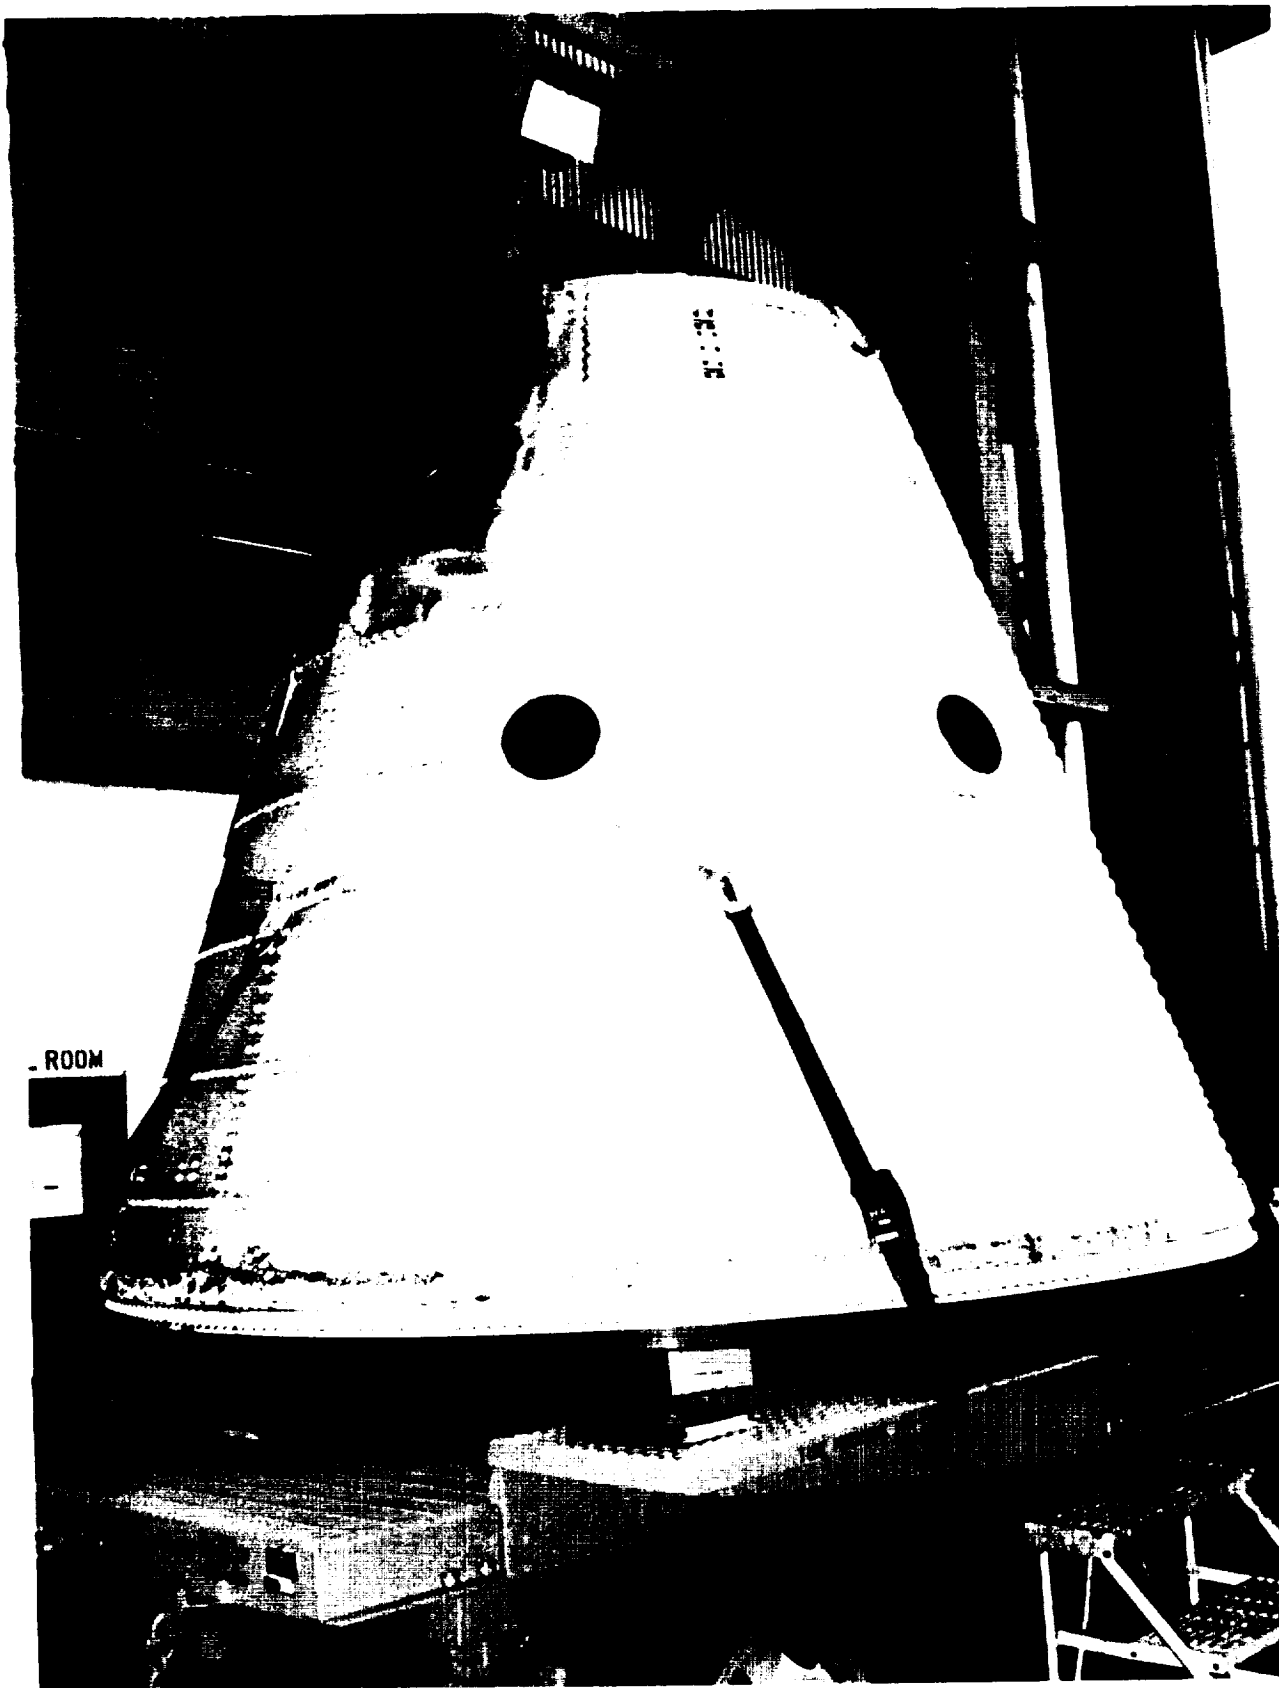
**Photo 24: LH Frustum**

The LH frustum was missing no TPS. The number of MSA-2 debonds over fasteners (54) and over acreage (2) was greater than average. Hypalon paint was blistered/missing along the XB-395 ring frame where BTA closeouts had been applied. However, most of the exposed BTA substrate was not sooted.

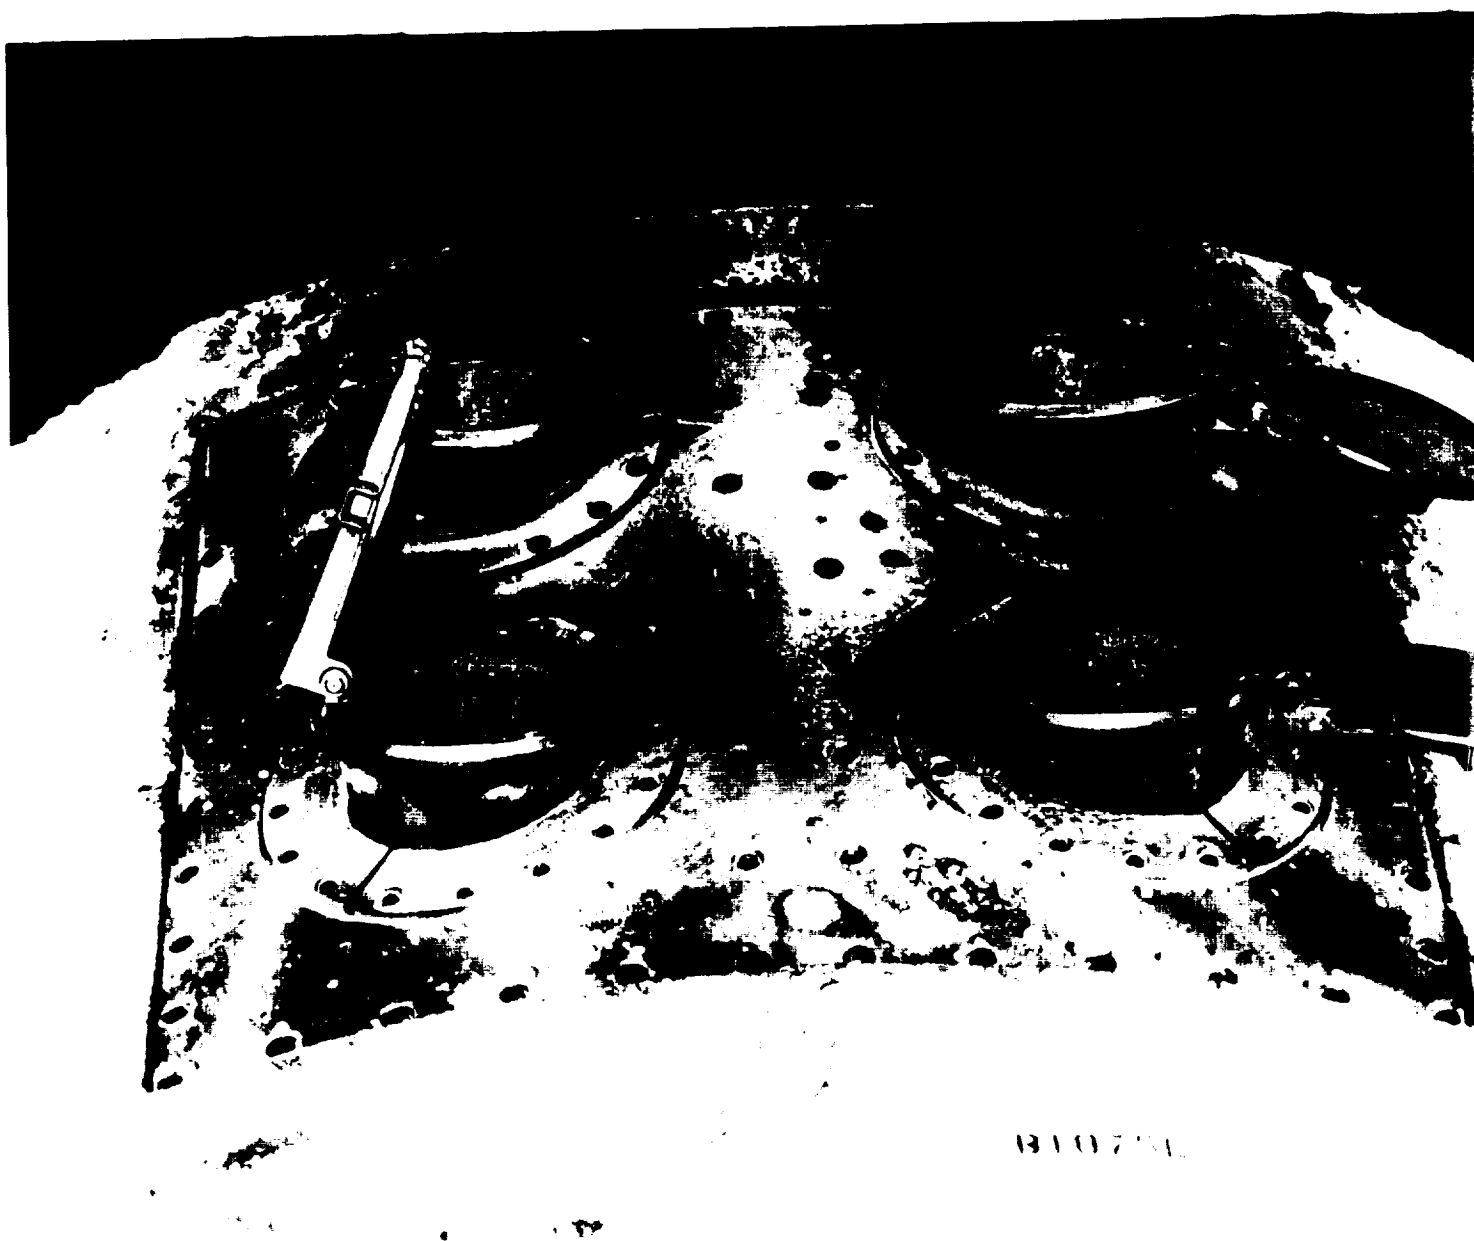
**Photo 25: BSM Aero Heat Shield Covers**

The BSM aero heat shield covers had locked in the fully opened position though the lower left cover attach ring had been bent. The upper left cover was missing. The damage to the BSM covers/attach rings was caused by parachute riser entanglement after splashdown.

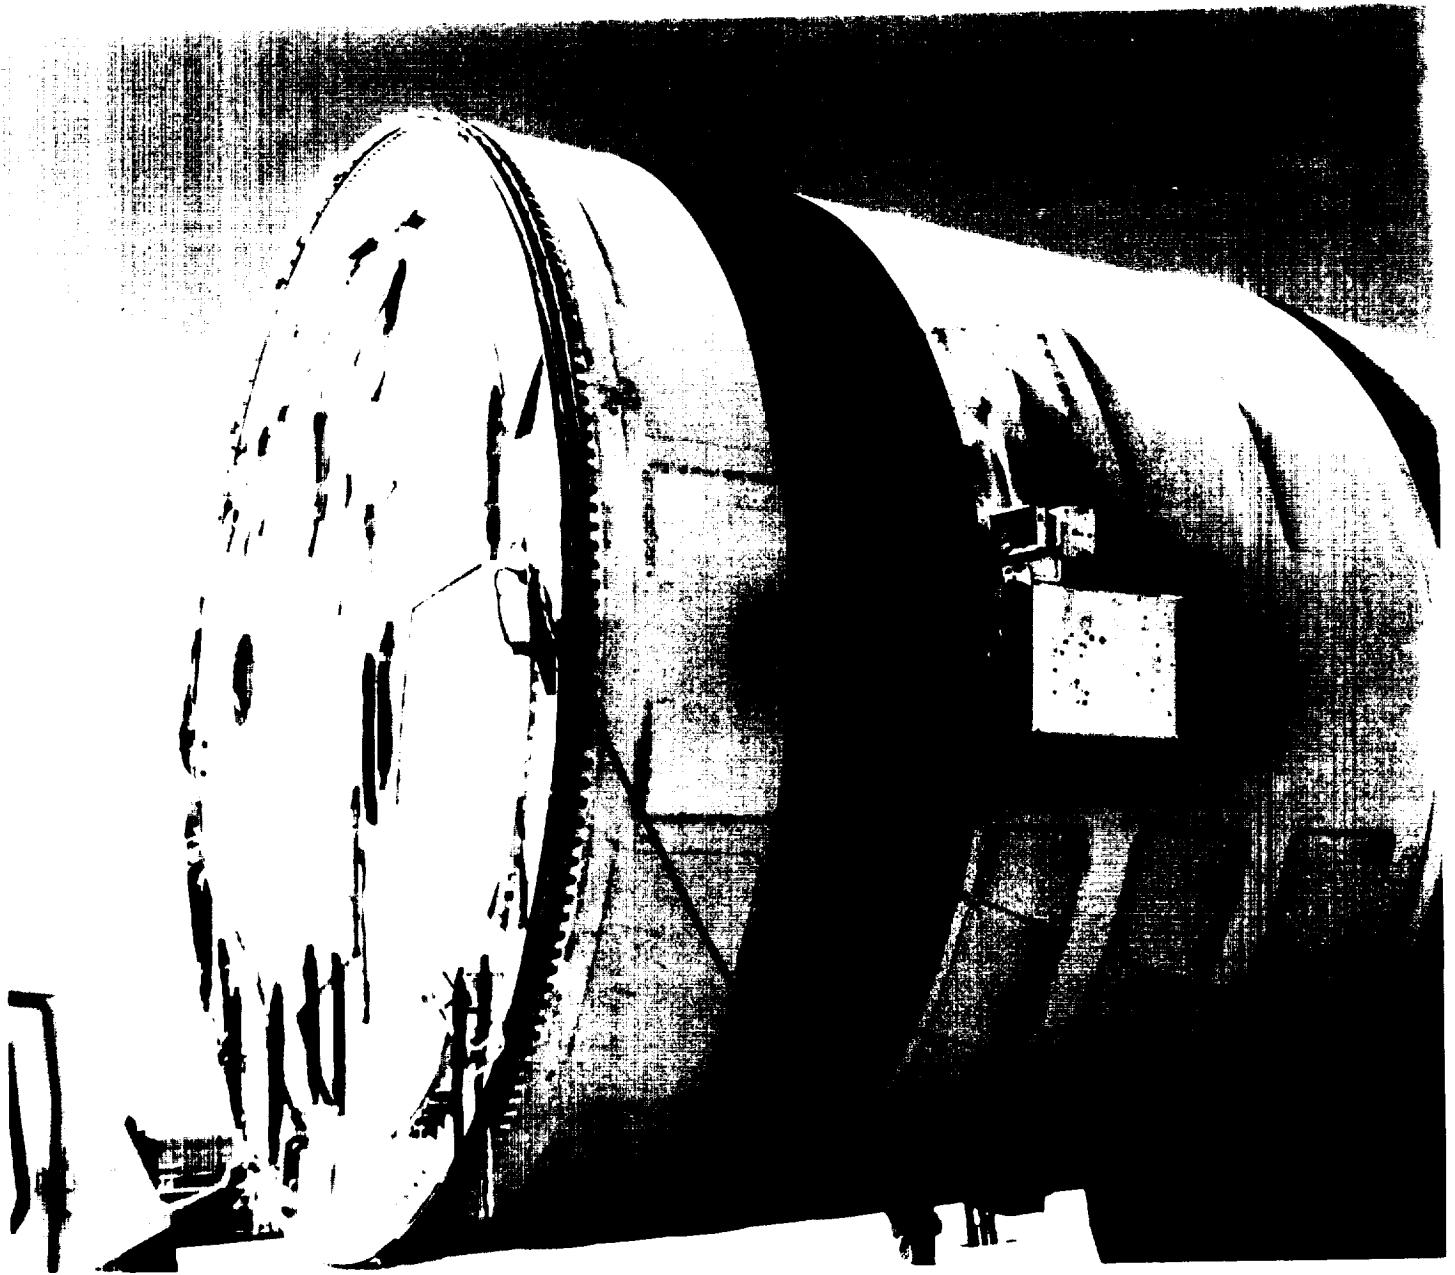
**Photo 26: LH Forward Skirt**

The LH forward skirt exhibited no debonds or missing TPS. Both RSS antennae covers/phenolic base plates were intact. Hypalon paint was blistered/missing over the areas where BTA closeouts had been applied.

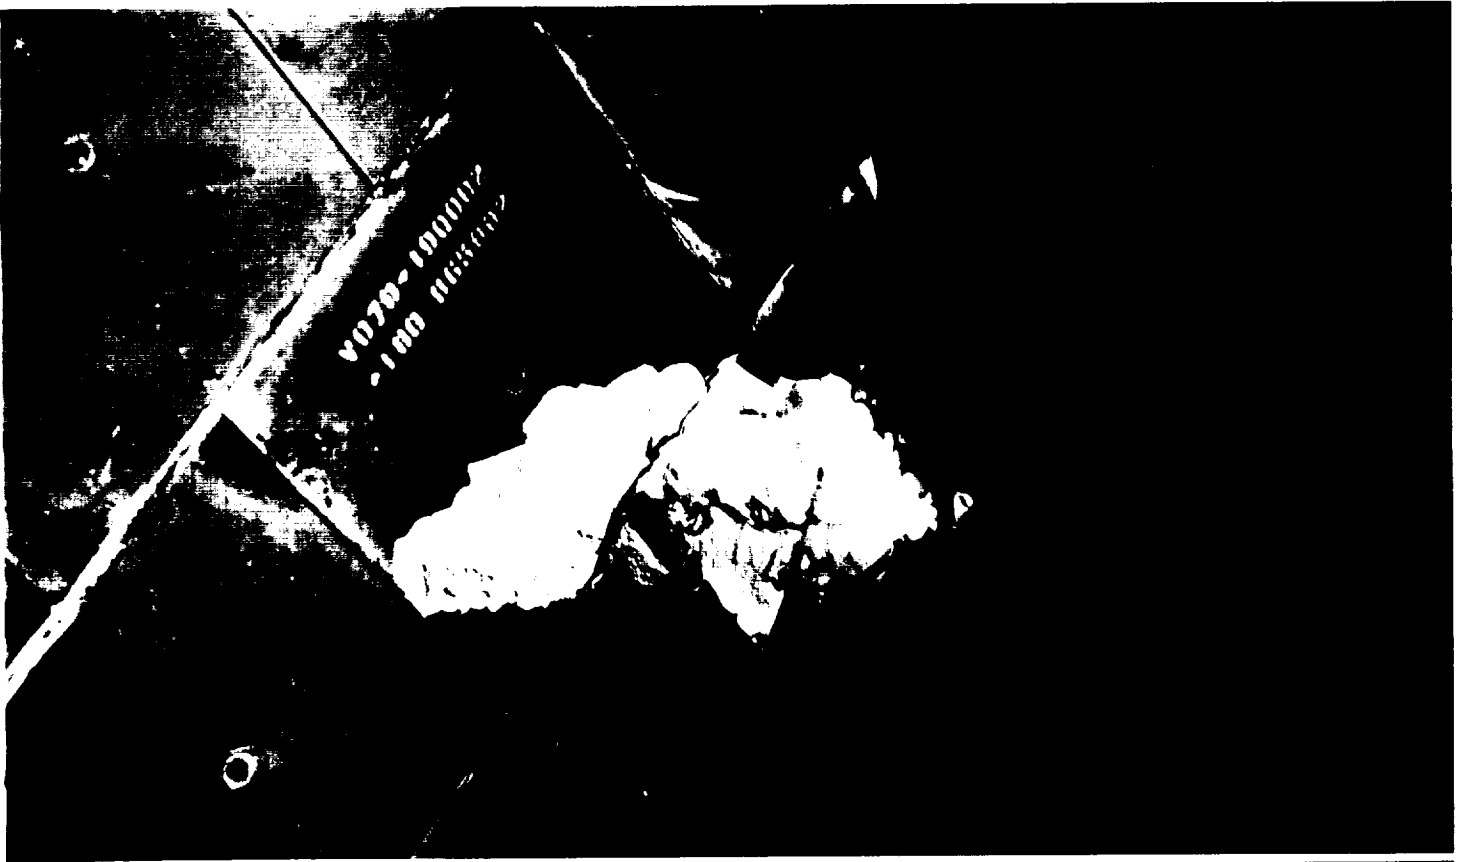
**Photo 32: Lower Surface Tile Damage**

Aerodynamic flow analyses performed at Rockwell-Downey showed debris sources/origins most likely to have caused this damage would have been located in the ET LO2 tank cable tray area. The LO2 feedline upper bellows, new-method bipod jack pad closeouts, and SRB nose cap ablator were much less likely debris source locations. However, review of ET/ORB umbilical camera films and on-orbit photography of the ET after separation from the Orbiter showed no anomalies that might have been the cause of the damage.

Two views showing a large tile damage site on the lower surface. The damage site, which measured 11.0 inches long by 3.8 inches wide by 0.8 inch maximum depth, showed significant signs of re-entry heating including interior glazing, slumping at the tile edge, and melting of the surface coating material.

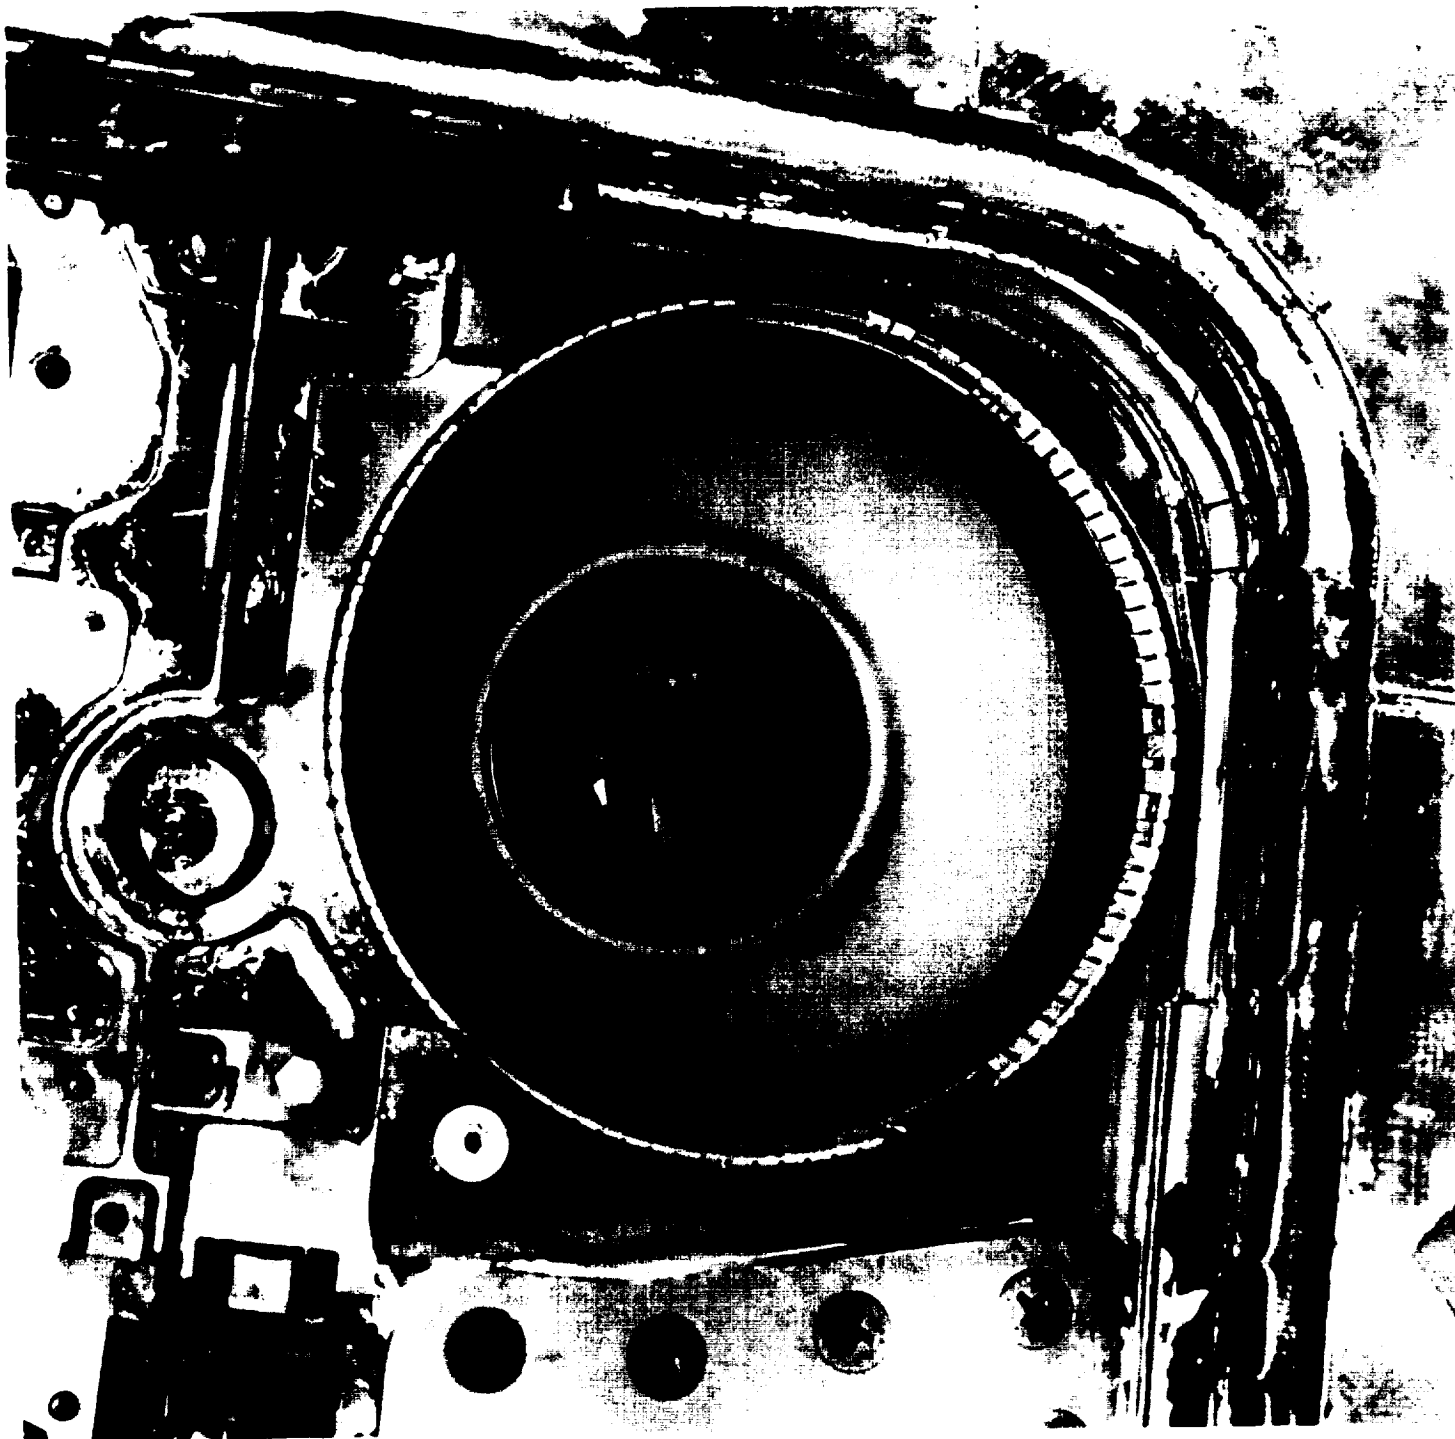
**Photo 35: ET/ORB Fitting Lining Clips**

ET/Orbiter separation devices EO-2 and EO-3 functioned normally. Numerous damaged clips on the "salad bowl" liners were noted: EO-2: two bent, two missing; EO-3: two bent, six missing.
